GEOLOGICAL SURVEY

Geologic Factors Pertinent To The Proposed A. J. Wiley Hydroelectric Project, No. 2845, Bliss, Idaho

Open-File Report 81-569

1981

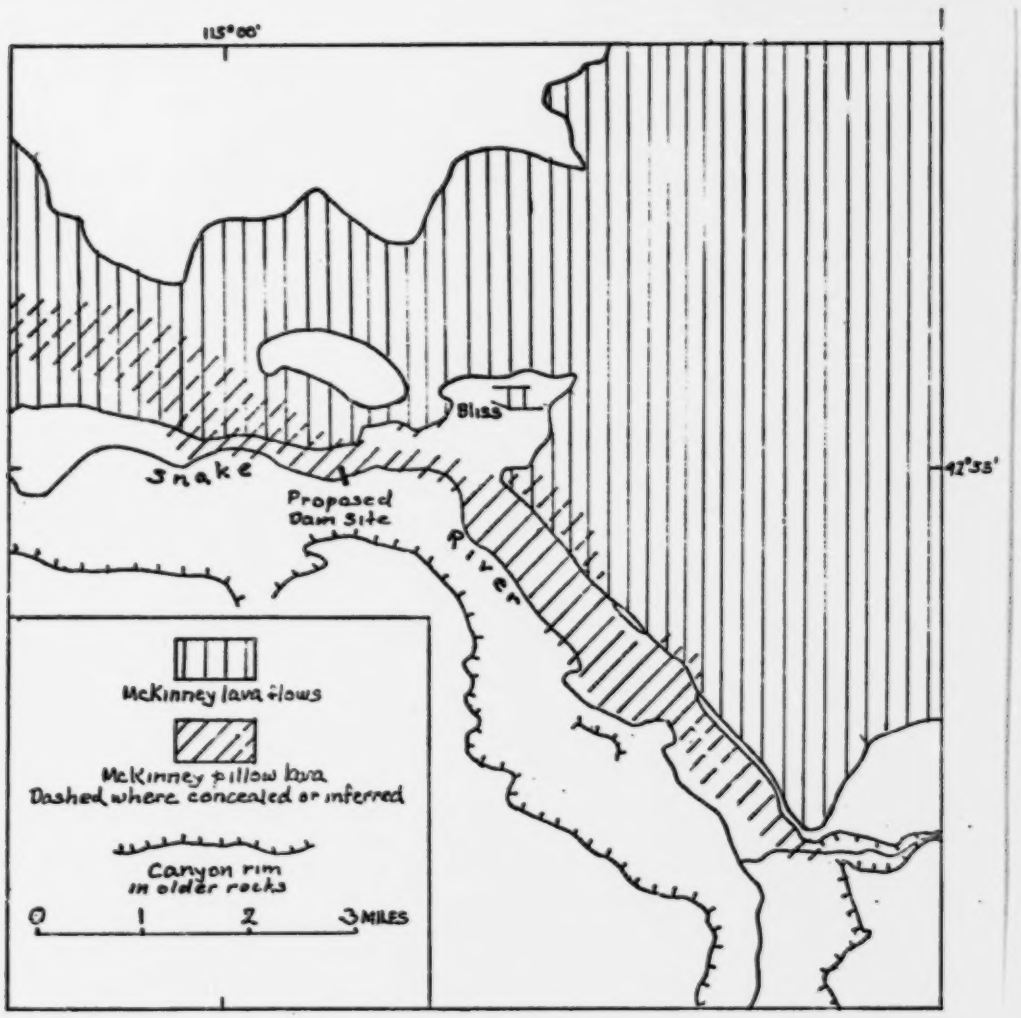
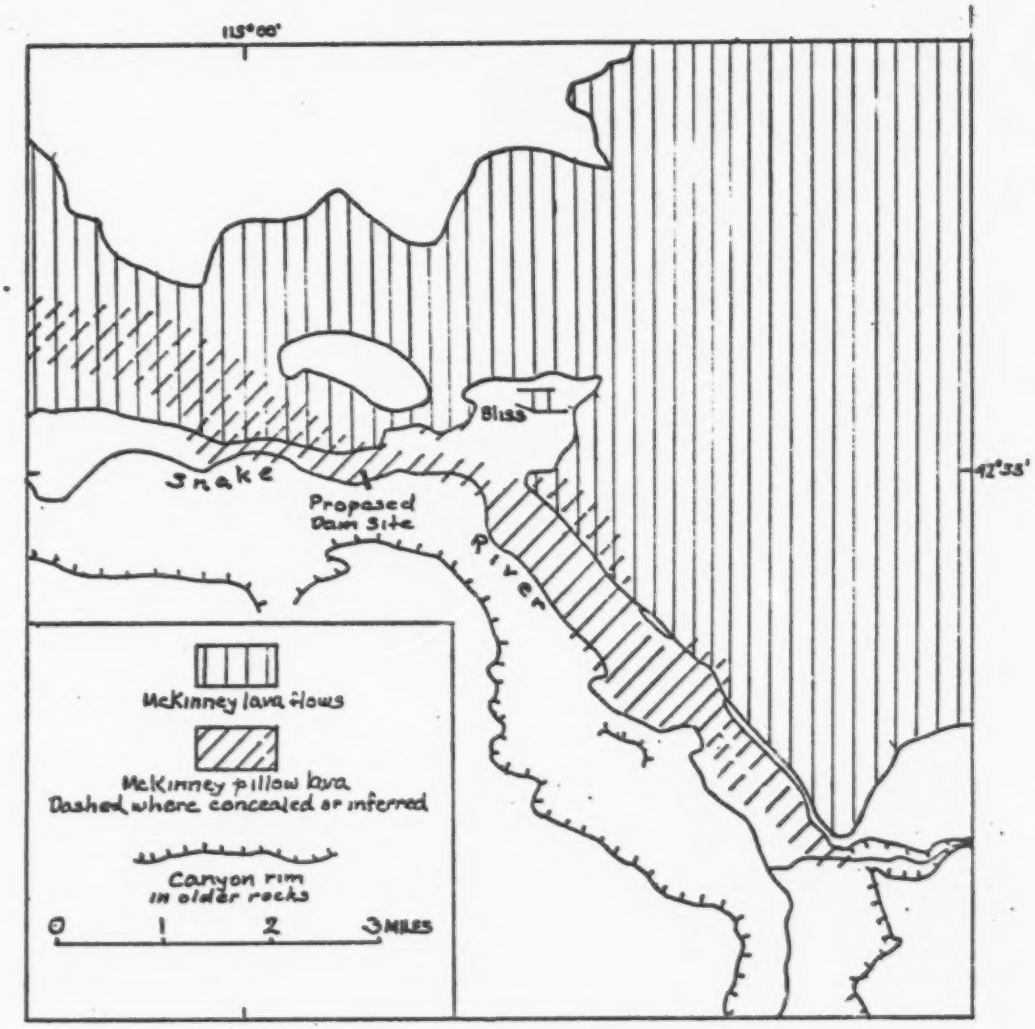
Figure 6.--Sketch map showing the distribution of McKinney Basalt near Bliss, Idaho. This geologic unit consists of pillow lava that occupies a former canyon of the Snake River and lava flows that rest on the pillow lava as well as on the surrounding upland. Edges of the lava flows are exposed as rimrock by erosion along the right side of the present canyon.

Based on the geology described in Part 3.4, McKinney pillow lava is thought to be continuous along the right side of the river from the right abutment of the proposed dam to the foot of the landslide at Bliss, a distance of about a mile. If the pillow lava is also present under the toe of the landslide, then a continuous hydraulic conduit extends at least 4 1/2 miles upstream via pillow lava in the concealed canyon to the right of the river, and possibly as far as 6 miles. Root Lake clay is virtually absent to the right of the river upstream from the Bliss landslide, and water of the reservoir would undoubtedly infiltrate the pillow lava and be discharged by leakage through the right abutment of the proposed site--assuming a connection through the landslide area--unless seepage from the proposed reservoir can be artifically impeded. An impervious blanket might be difficult and costly to install and maintain along this reach, not only because of its length, but also because long stretches consist of Melon Gravel, which forms unstable slopes.

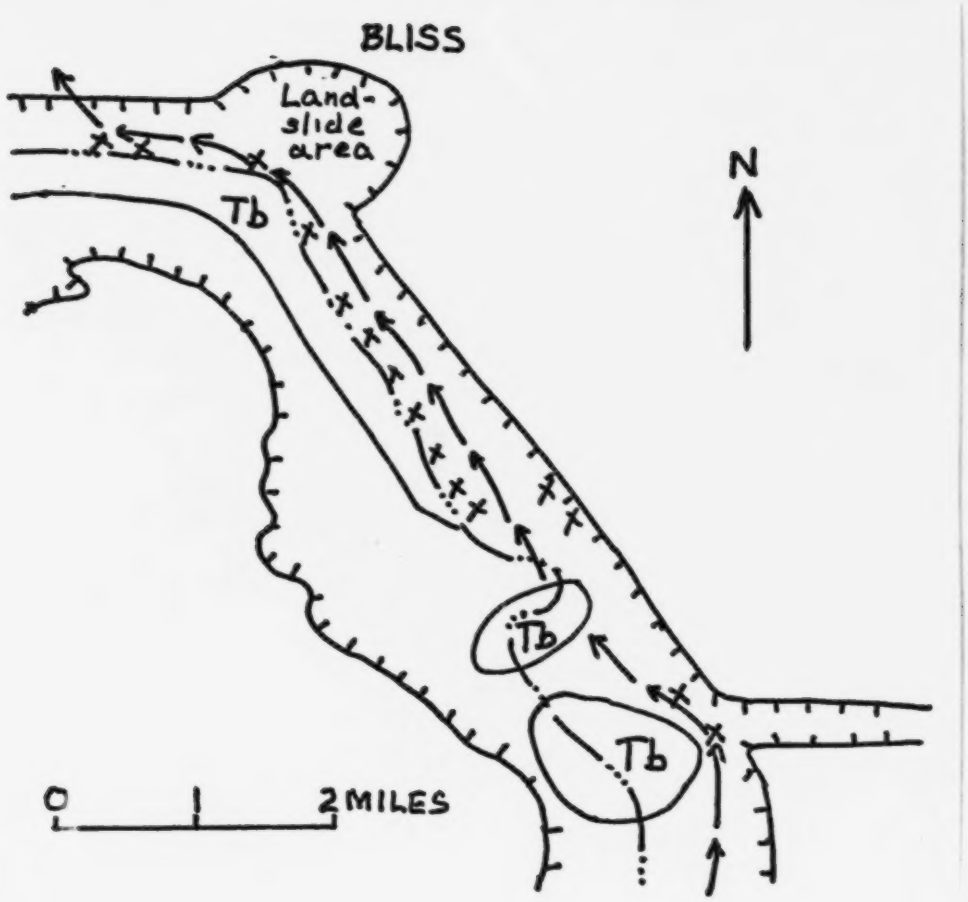
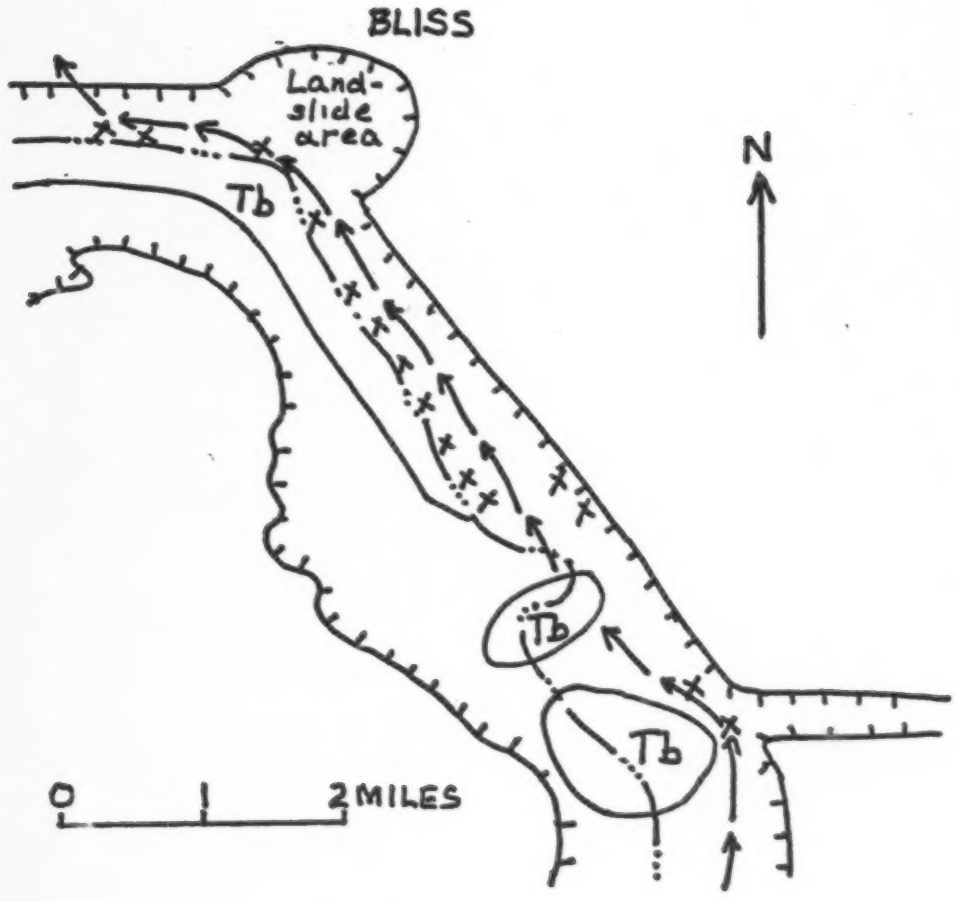
From the proposed dam site to the Bliss landslide, McKinney pillow lava is continuously exposed except for a covered interval from 0.3 to 0.7 of a mile above the dam. The covered interval is at the foot of a segment of the canyon wall that closely corresponds with the right wall of the former canyon, judging from a remnant of Madson Basalt below the canyon rim. Because Banbury Basalt along the left wall is exposed 500 feet south of the river, the floor of the former canyon must lie approximately beneath the river. The depth of the former canyon in the right abutment of the proposed dam (altitude 2,550 feet) indicates that the canyon floor can be expected to be about 100 feet below the

Figure 8.--Sketch map showing inferred continuity of McKinney pillow lava (crosses) in a concealed trench (arrows) to the right of the present Snake River near Bliss, Idaho. The trench is cut in Banbury Basalt (Tb). Seepage from the proposed reservoir would follow pillow lava in the trench and would be discharged around the right abutment of the proposed dam. The present canyon rim is shown by hachures.

river at this place, covered by a substantial thickness of pillow lava. Drilling to test this inference would be desirable because of the connection that might be thereby confirmed with pillow lava farther upstream. Such a connection would augment the length of the reservoir where water could be carried to the right abutment via the concealed canyon fill of pillow lava. Also, if such a connection is confirmed, the task of installing an impervious blanket to prevent leakage from the proposed reservoir into the pillow lava--assuming that no other remedy is more practial--would be greatly increased. The length to be sealed would reach at least a mile upstream, and an undetermined amount of river gravel might have to be removed from the reservoir floor before a sealant could be effectively applied.

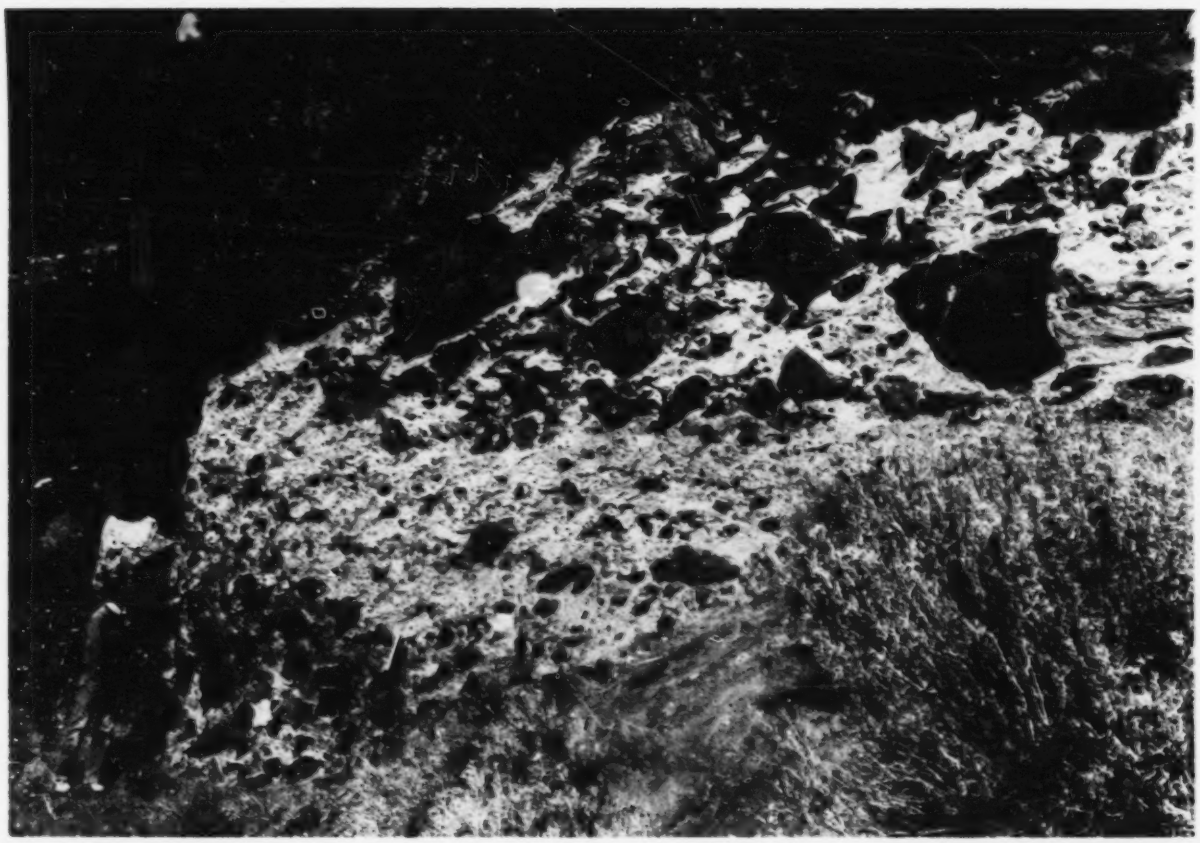
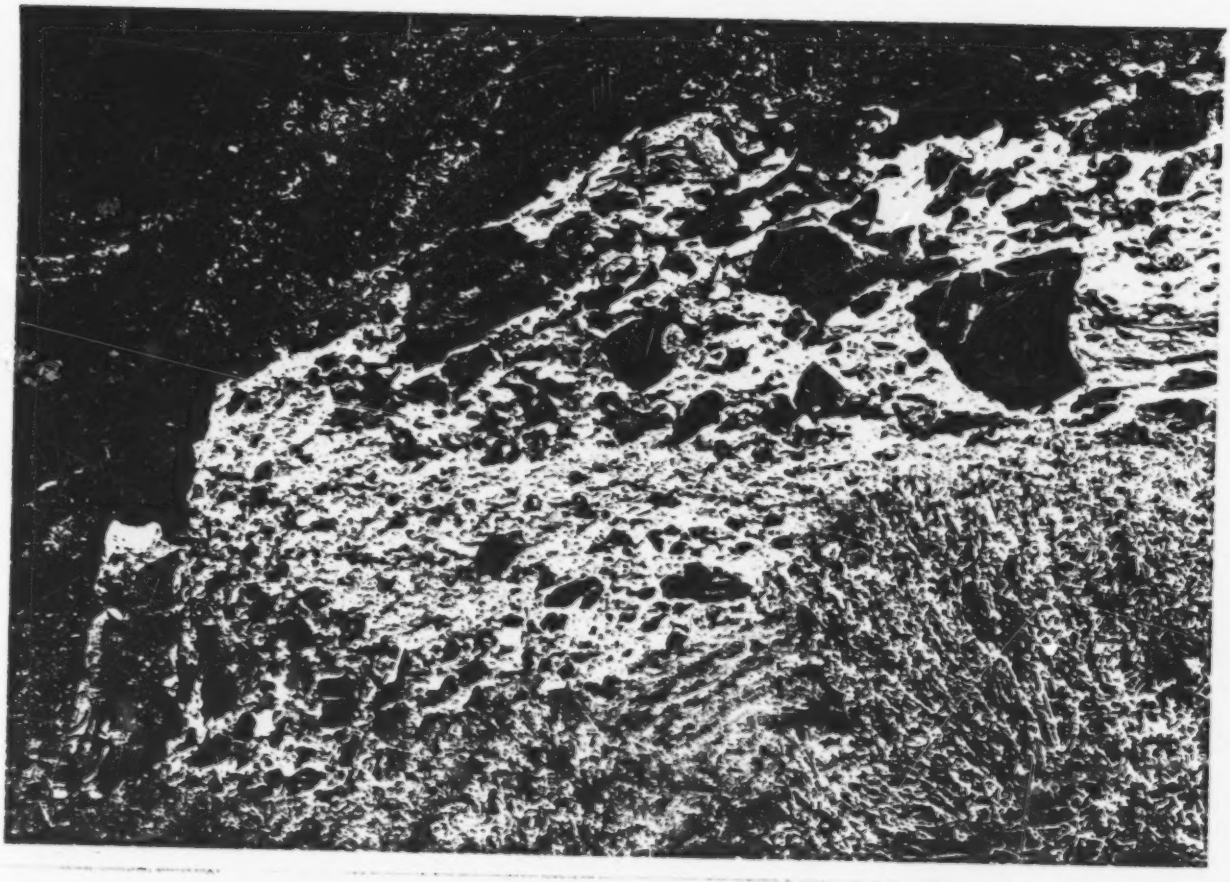
As shown in figure 10, a conspicuous feature of most of the debris is mixed sizes of basaltic blocks surrounded by a matrix of light-colored clay, silt, and sand. The basalt pieces range in size from small pebbles to blocks several feet across. They are highly altered and resemble the lithology of Banbury Basalt in the area, although some of them may have been derived from a local lava flow in the Glenns Ferry Formation, which is also strongly altered. Many of the basalt pieces are angular, even to the extent that corners form acute angles. In contrast, the matrix is almost entirely fine grained, although small pebbles of clay and silt can be found that are undoubtedly coherent pieces derived from older sedimentary deposits, probably the Glenns Ferry Formation. A few such pieces are several feet across (fig. 11). Also, some parts of the debris consist of small fragments of sediment and basalt in approximately equal proportions (fig. 12). During the field conference, Jack Duckworth found that pieces of the matrix slake and fall apart when placed in water.

In figure 10, the debris can be roughly divided into three layers, although the contacts between layers are gradational. Neither layer can be said to be sorted, but some sorting into thinner intervals with contrasting textures can be discerned in the middle layer. These layers have very limited lateral extent. About 150 feet along the outcrop northwest of the area of figure 10, the same layers are no longer recognizable, and the debris has a very different appearance (fig. 12).

Figure 10.--Part of a layer of mixed debris equal to the applicant's "older alluvium" beneath fragmental basalt of McKinney pillow lava at an outcrop half a mile downstream from the proposed dam and 50 feet above the Snake River (2,500 ft. S., 400 ft. W., NE cor., sec. 11, T. 6 S., R. 12 E., Bliss quad.).

appropriate tests should be made to determine its behavior when wet. Based on these determinations, a stability analysis through the embankment would provide an estimate of predicted stability. For the intake and spillway sections, a similar analysis is needed, together with an evaluation of the potential for differential settling. Unequal subsidence could be caused by differences in consolidation characteristics of the debris and the pillow lava. Depending on the tests and the findings about the lithologic variability of the debris under the proposed structure, the wise course might be to completely excavate the debris from the area of the dam site.

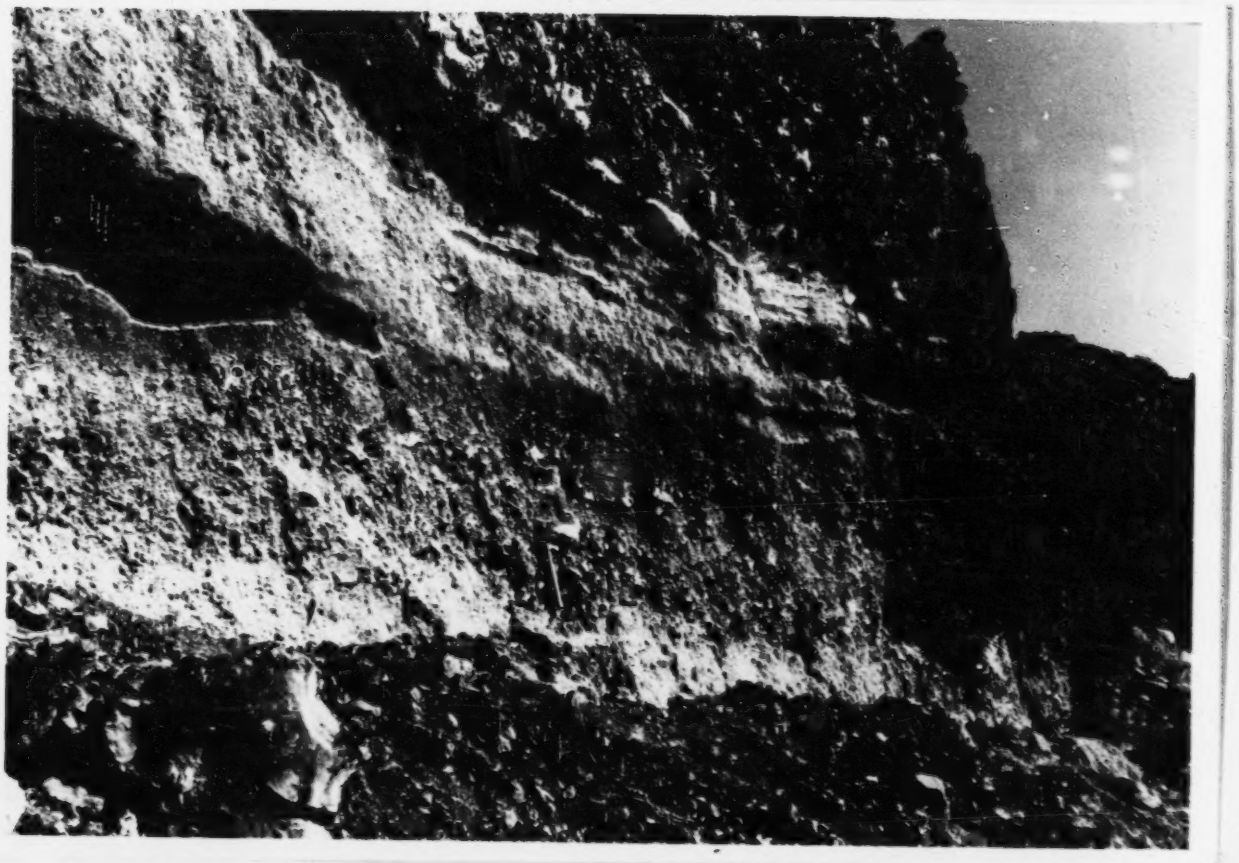
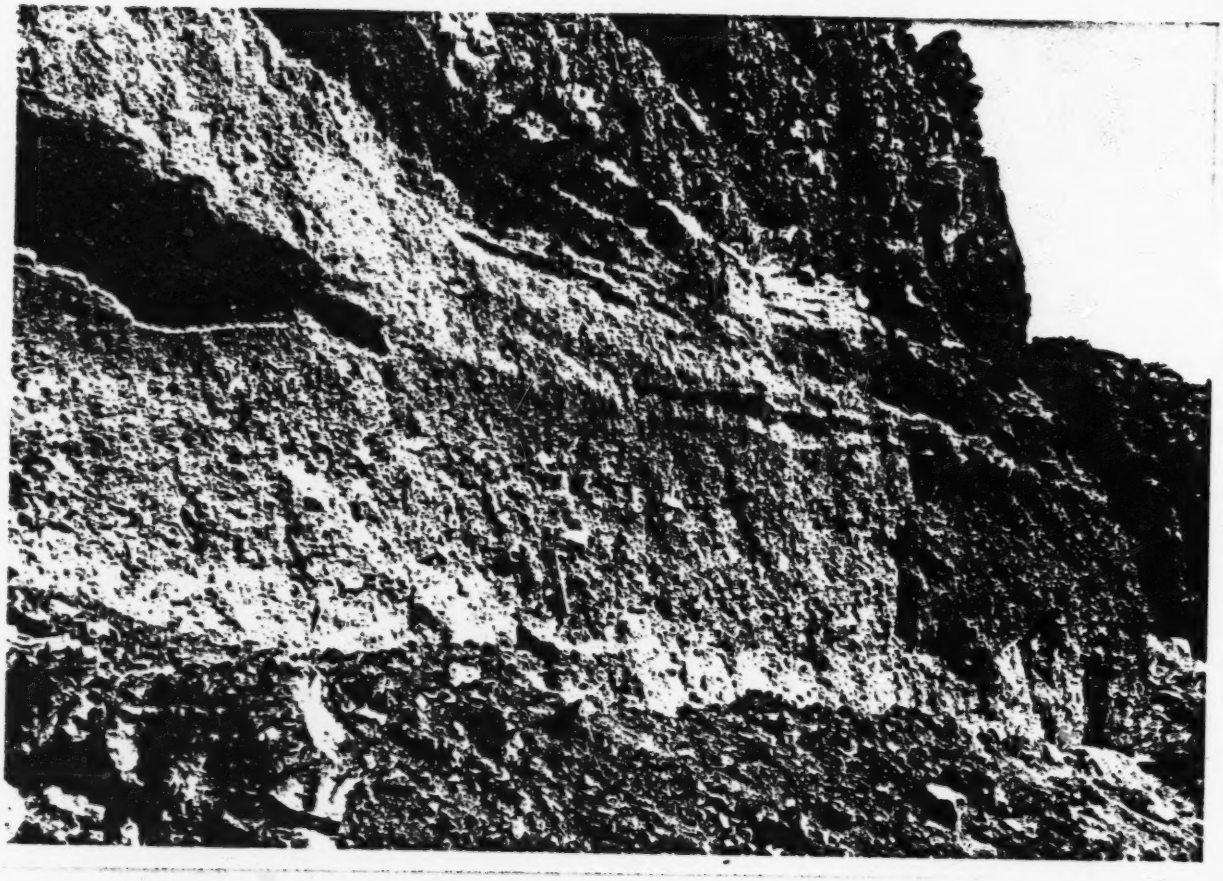
Figure 12.--Debris under fragmental basalt of McKinney pillow lava at a place 150 feet northwest of the area of figure 10. Material at the level of the geologic hammer is a mixture of irregular pieces of basalt and poorly consolidated sediment (primarily clay and silt) in approximately equal proportions. At the left, the debris surrounds a tongue-shaped layer of McKinney fragmental basalt. At the upper center, the contact between the debris and the overlying McKinney appears to be gradational. The stratigraphic relations imply that the debris was being deposited during the first stages of accumulation of the pillow lava.

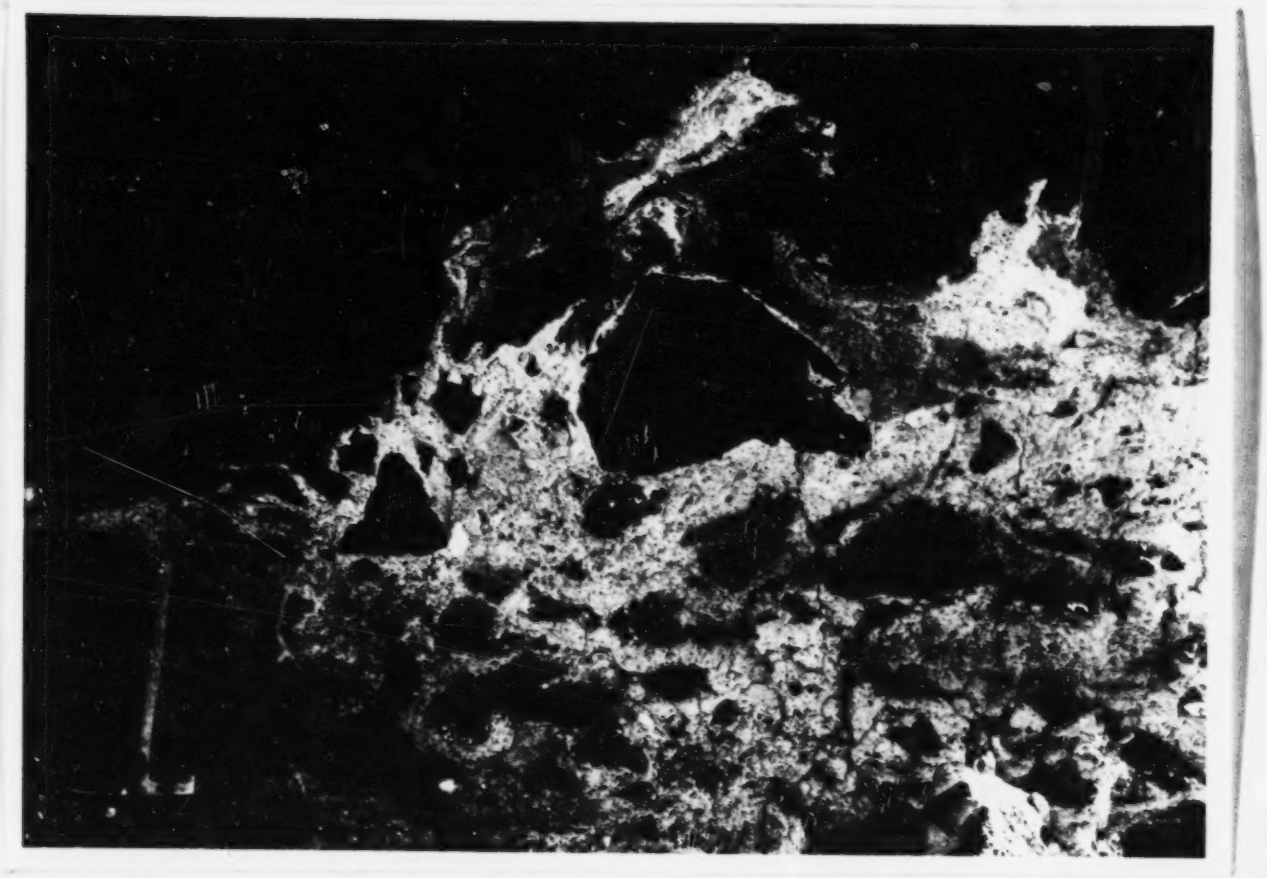
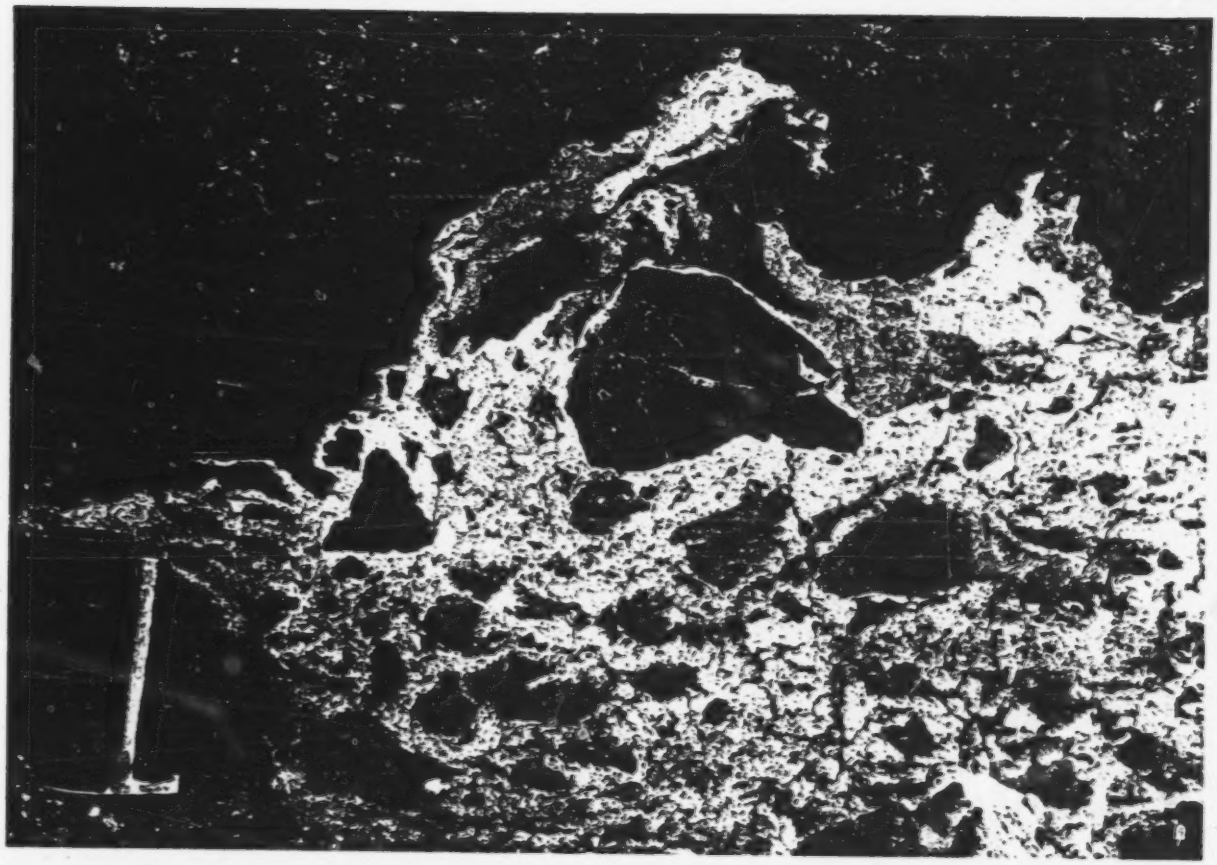
Together, the poor stratification and lack of sorting of the debris, its discontinuous lithology, and the acute angularity of its larger components support the concept that the debris was deposited as a viscous fluid. Such an origin is also indicated by the nature of the contact with the overlying McKinney pillow lava, which in places displays convolutions that are best attributed to a high degree of fluidity in the matrix of the debris (fig. 13).

Figure 13.--Deformed contact of fragmental McKinney pillow lava on debris at a place 75 feet northwest of the outcrop shown in figure 10. Light-colored clay, silt, and sand that makes up the matrix of the debris forms plumes, or "flame structures" (Potter and Pettijohn, 1977, p. 199-200), that rise complexly into the overlying fragmental basalt. Features of this kind reflect deformation by viscous flow.

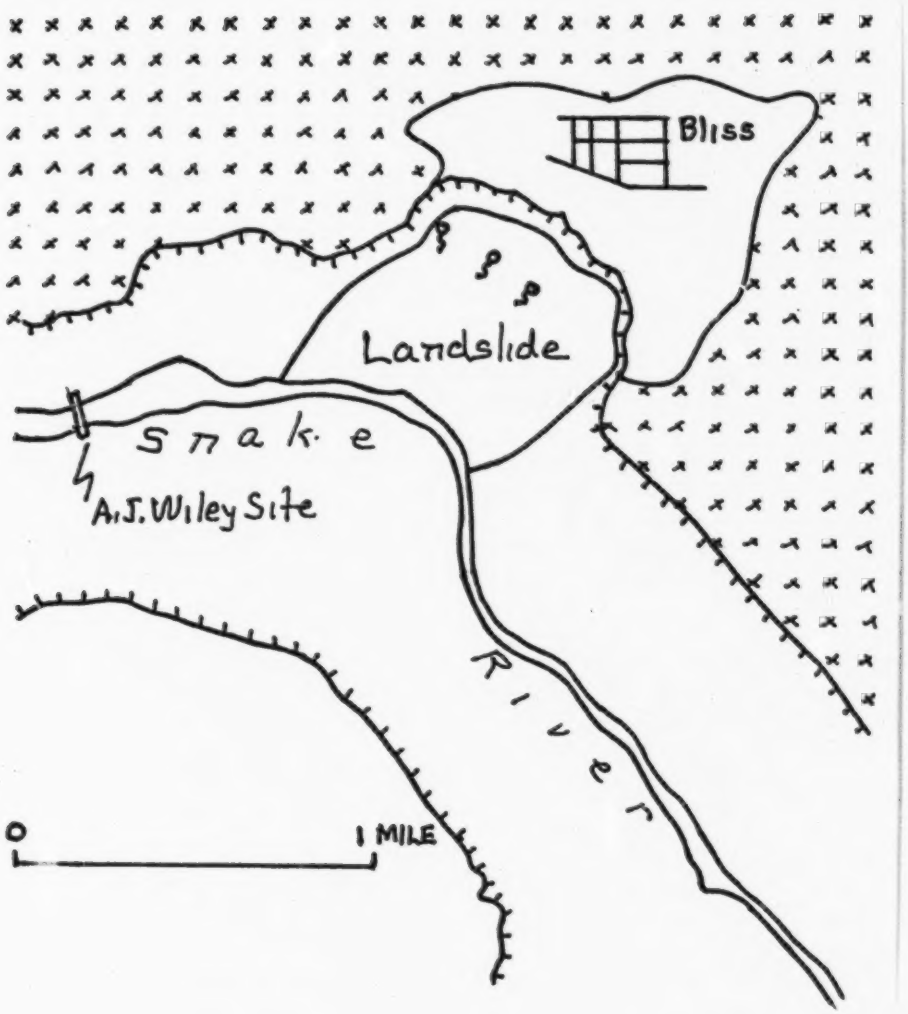
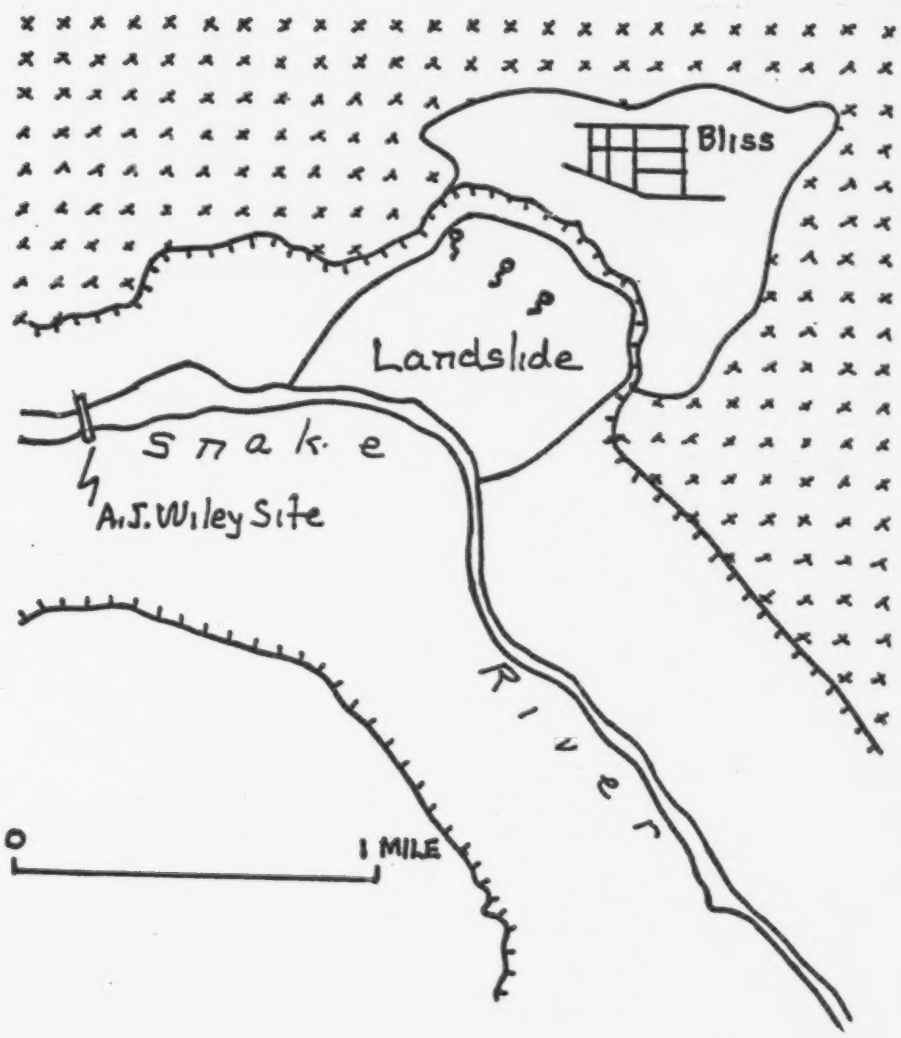
The slide covers half a square mile. A conspicuous bench at an altitude of 2,925 feet extends across most of its width, such that the part descending to the Snake River has a gradient of about 22 percent, and the slope above the bench has a gradient of about 15 percent. Because the top of the Banbury Basalt in the area is at an altitude of 2,875 feet, and because the Banbury is undoubtedly present beneath the landslide (Part 4.2), the bench is possibly a topographic expression of the comparatively resistant Banbury, concealed by at least 50 feet of landslide deposits.

Figure 14.--Sketch map of the area around the Bliss landslide showing the town of Bliss, Idaho, on poorly consolidated sediments, surrounding lava flows of McKinney Basalt that form the canyon rim to the west and south (pattern), and a line of seeps that trends northwestward near the head of the landslide.

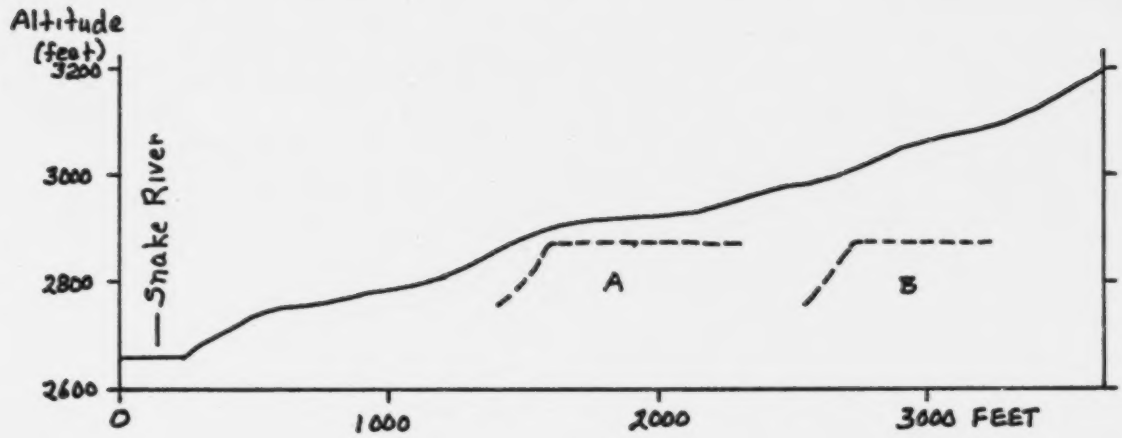
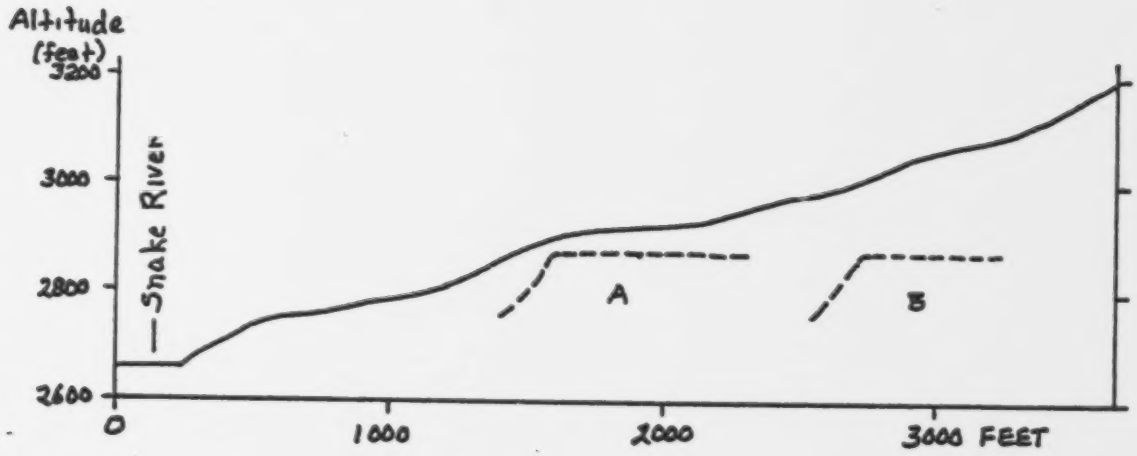
Of particular concern in the upper part of the landslide is the position of the Banbury Basalt, which underlies the Glenns Ferry Formation. If the concealed Banbury is relatively near the front of the slide, at position A in figure 15, it can be expected to increase the stability of the upper part of the landslide--at least in the sense of providing a relatively resistant buttress to movements that may begin at a higher level. On the other hand, if the Banbury is deeply buried by the upper part of the landslide, lying at position B in figure 15, or if it is below the reach of existing slippage surfaces, it would provide little or no resistance. In this circumstance, movements in the upper part of the slide might be propagated to the lower part. An even greater potential danger is that calving at the reservoir might advance upward to the head of the landslide, perhaps leading to enlargement of the slide by headward retreat.

Elsewhere along the canyon of the Snake River, some large landslides in the Glenns Ferry Formation seem to have formed by sudden failure of massive sections of the canyon wall, thus producing widespread sheets of debris in lowland areas. Good examples may be seen in a landslide that covers about 2 1/2 square miles in an area 2-3 miles northwest of King Hill and on the north side of the canyon at the head of Indian Cove. Therefore, large-scale instantaneous collapse of the Bliss landslide is possible, even though large slides of more or less coherent masses are more generally to be expected primarily in indurated rocks (Müller, 1968). Because of the potential hazard, it would be prudent to evaluate the likelihood of widespread failure of the Bliss landslide by making a complete stability analysis. Sudden large-scale collapse of the landslide could displace a substantial part of the proposed reservoir. In this event, the displaced water almost surely would overtop the dam.

Figure 15.--Representative profile of the Bliss landslide showing two hypothetical positions of concealed Banbury Basalt: A, close to the front of the slide; and B, deeply buried by the upper part. The vertical scale is exaggerated by a factor of two.

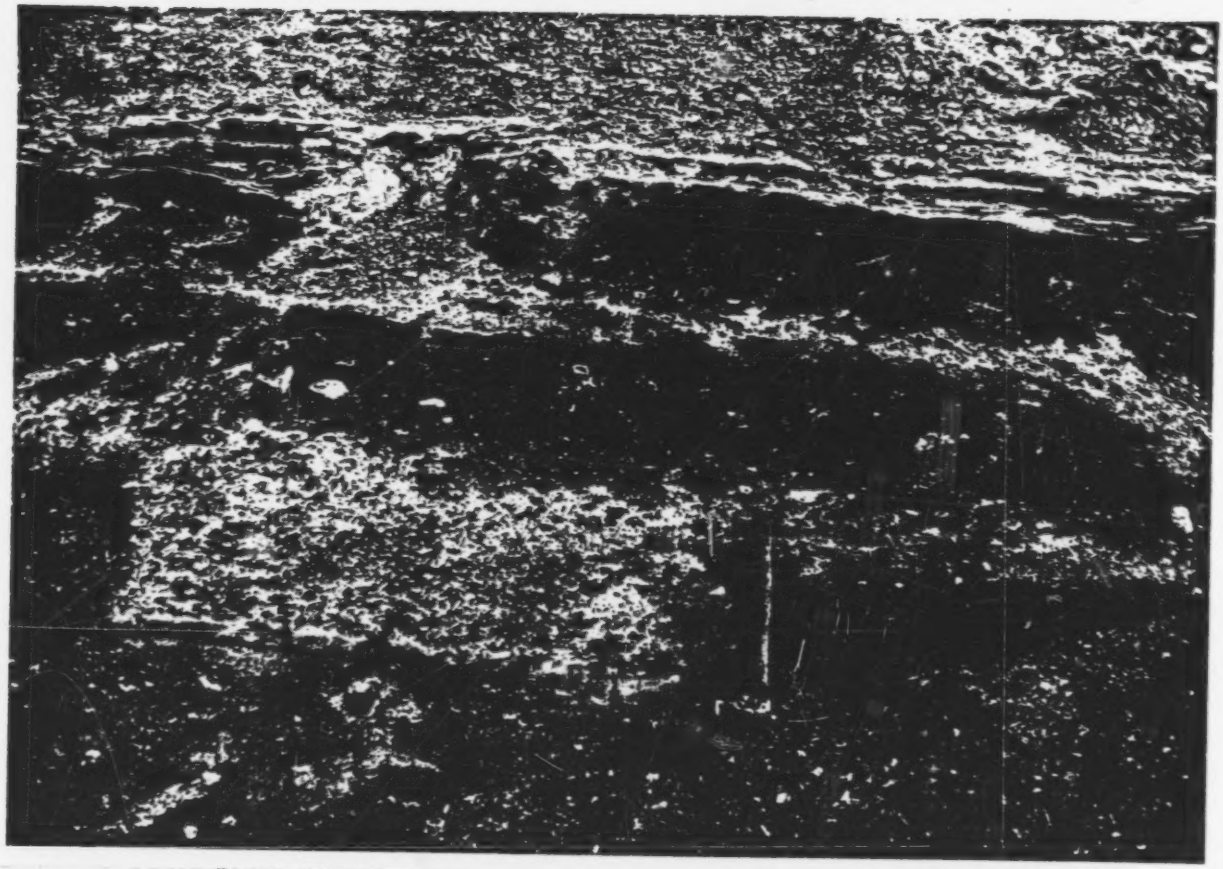
Figure 4.--Outcrop at the south end of the Shoestring Road Bridge showing layers composed dominantly of glassy fragments typical of the McKinney pillow lava overlain by laminated Root Lake clay. The upward change from fragmental basalt to clay takes place in an interval about 8 inches thick, which is characterized by alternating laminae of these materials.

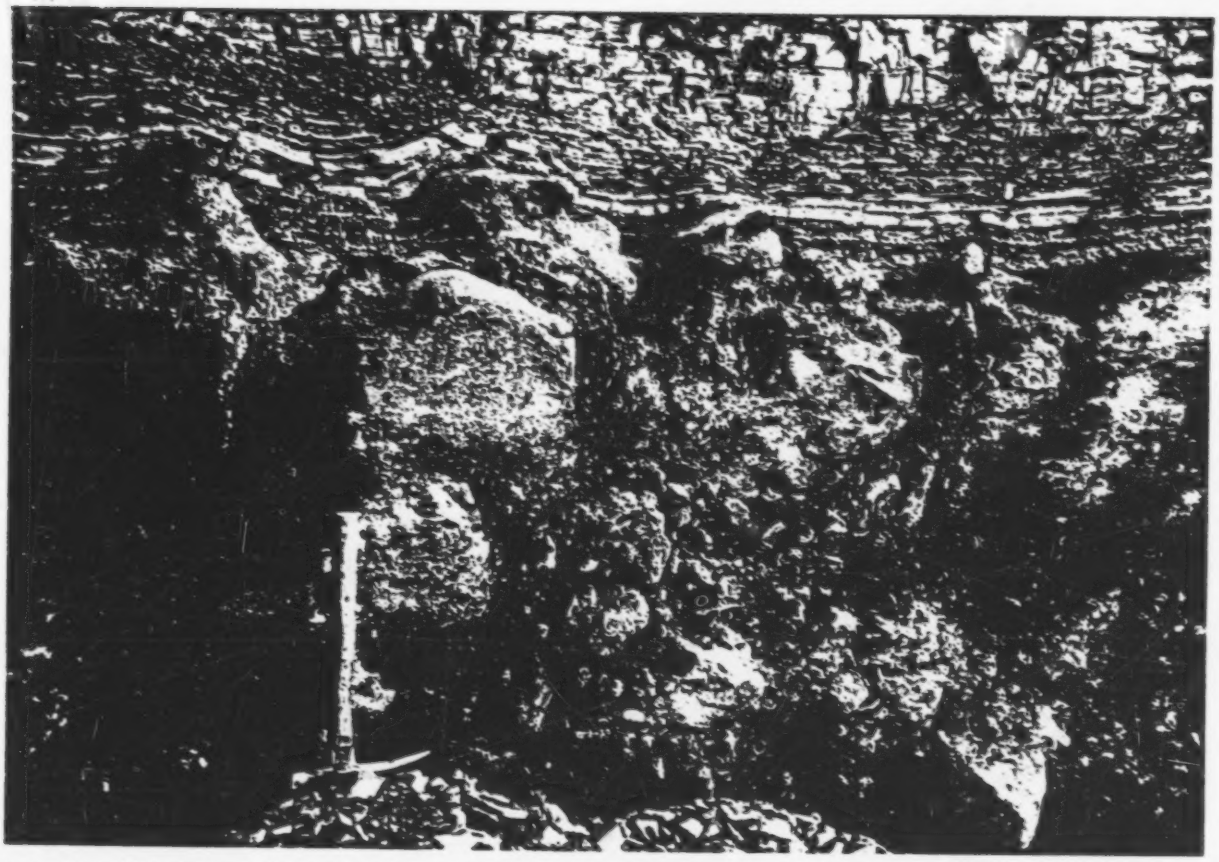
Figure 5.--Outcrop at the west end of the former siphon for the King Hill Canal showing laminae of Root Lake clay that engulf irregularities at the upper boundary of blocky rubble. The rubble contains substantial amounts of glassy fragments typical of the McKinney pillow lava. The glassy fragments are seen in the photograph as darker areas of granules and small pebbles, which occur as interstitial material between blocks in the rubble and as larger masses surrounded by blocky constituents.
